ON-SITE AIR BAG INVESTIGATION

CASE NO. - 96-16
FLEET - PRIVATE VEHICLE
LOCATION -
ACCIDENT DATE -

TRC/IU CASE NO. 96-16

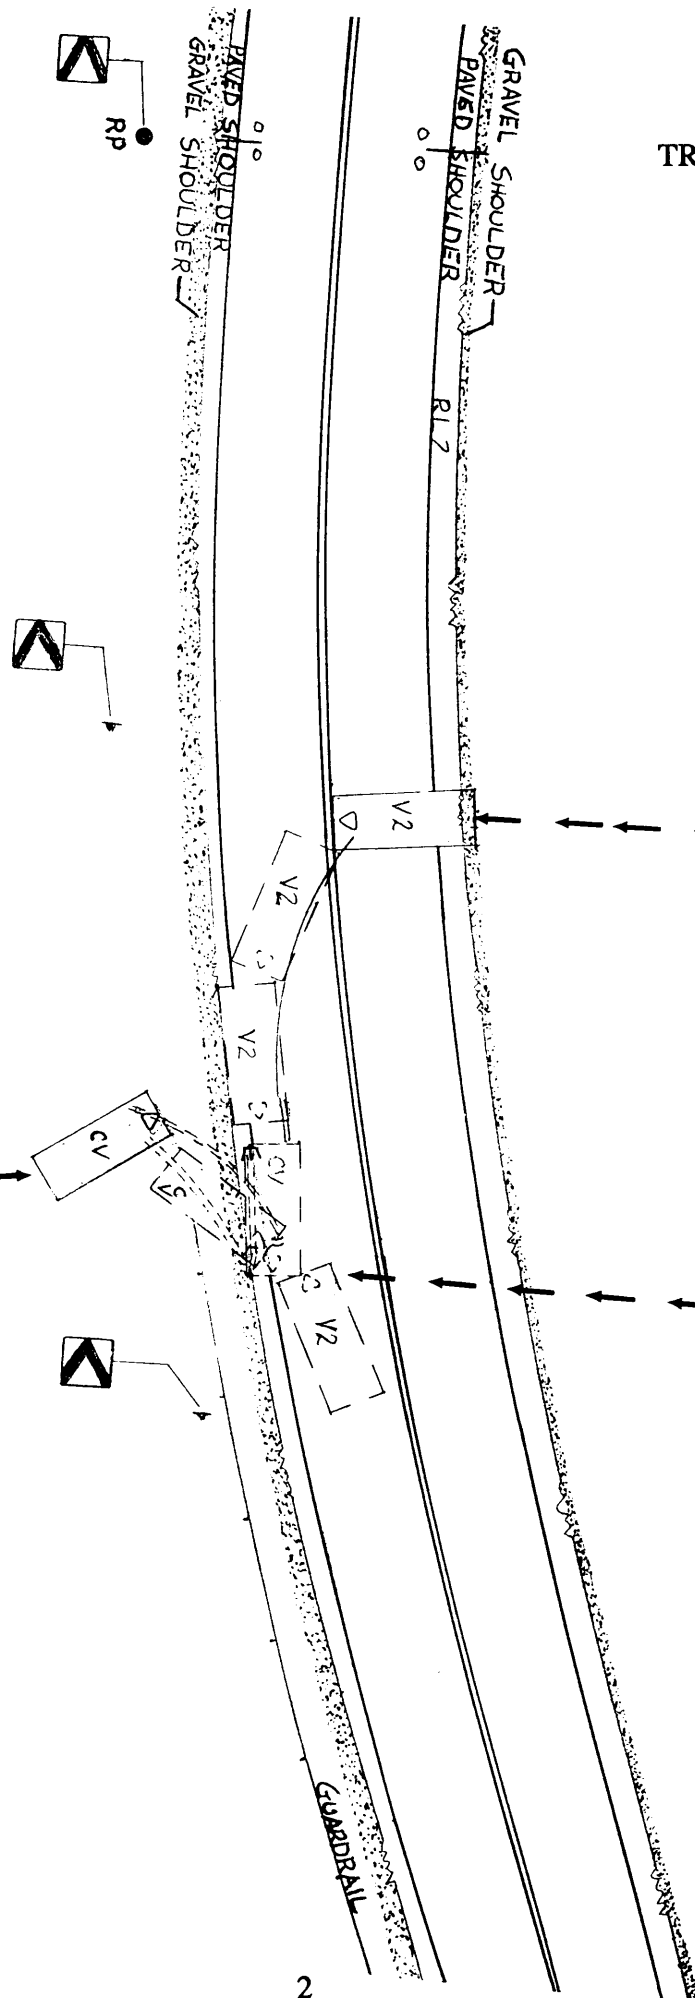
Point of impact and gouge mark from Vehicle #2 indicating location where Vehicle #2 began rotating counterclockwise

Road Surface: Asphalt
Road Condition: Wet
Curvature: Left-hand curve for Case Vehicle, Right-hand curve for Vehicle #2
Grade, at-impact: -2.9 % for Case Vehicle
Superelevation, at-impact: 8.7 % positive to south

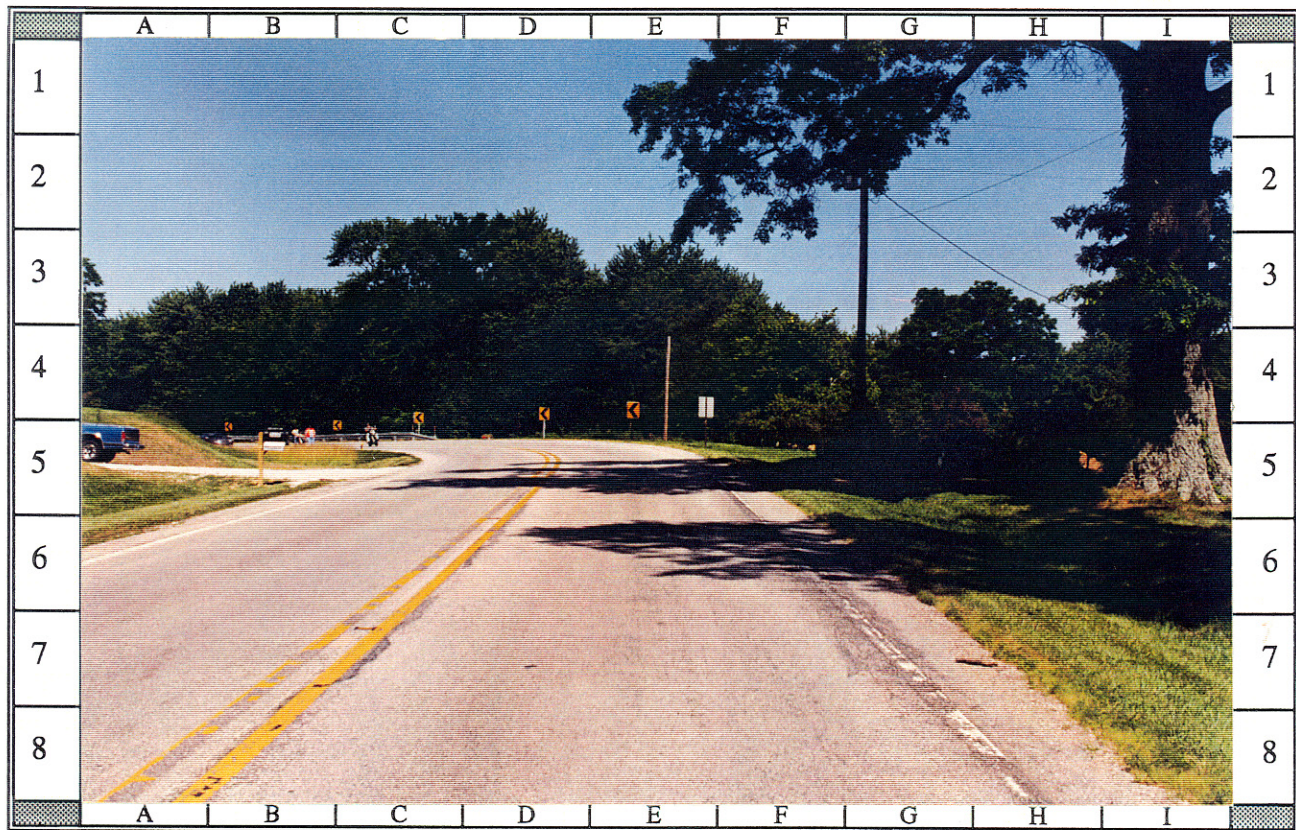
01: Case Vehicle's eastward travel path approaching left hand curve approximately 90 meters (295 feet) west of impact area

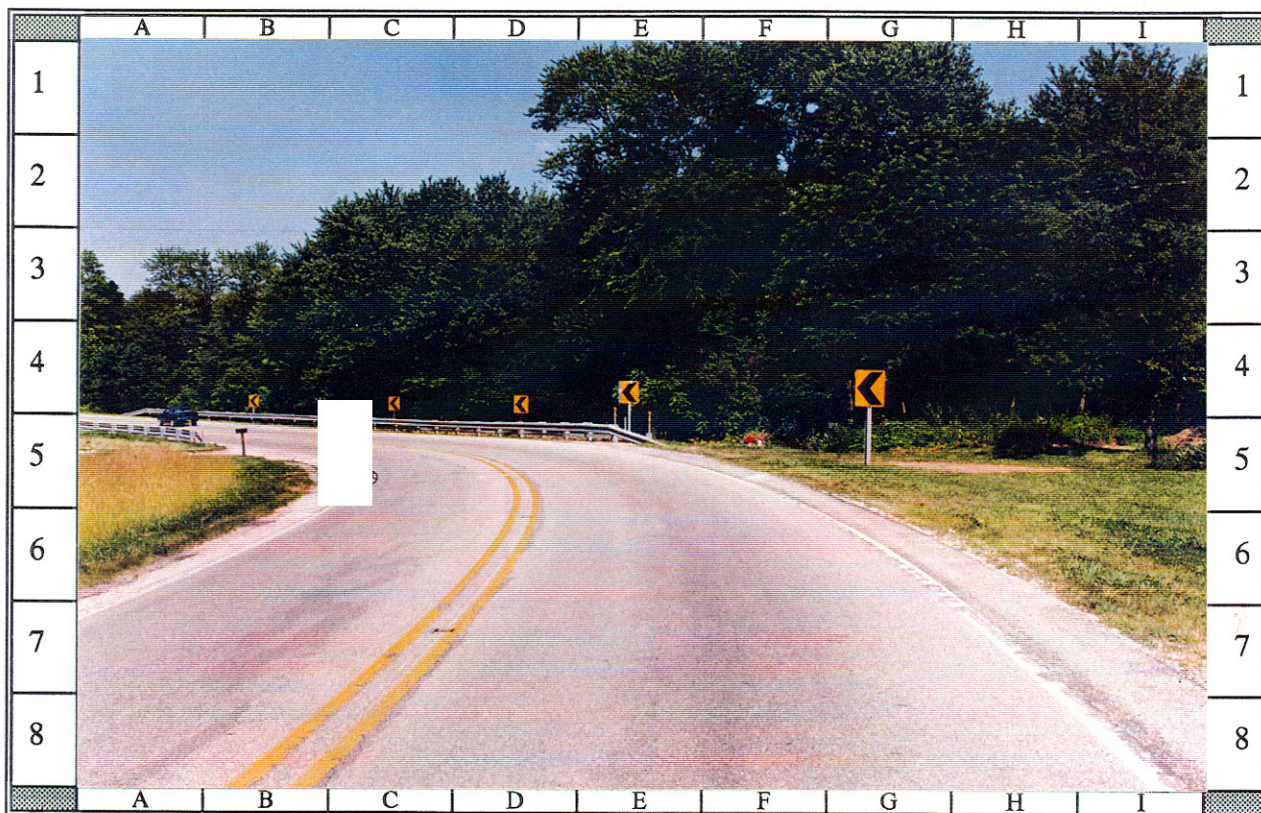
03: Case Vehicle's eastward travel path in left hand curve approximately 40 meters (131 feet) west of impact area

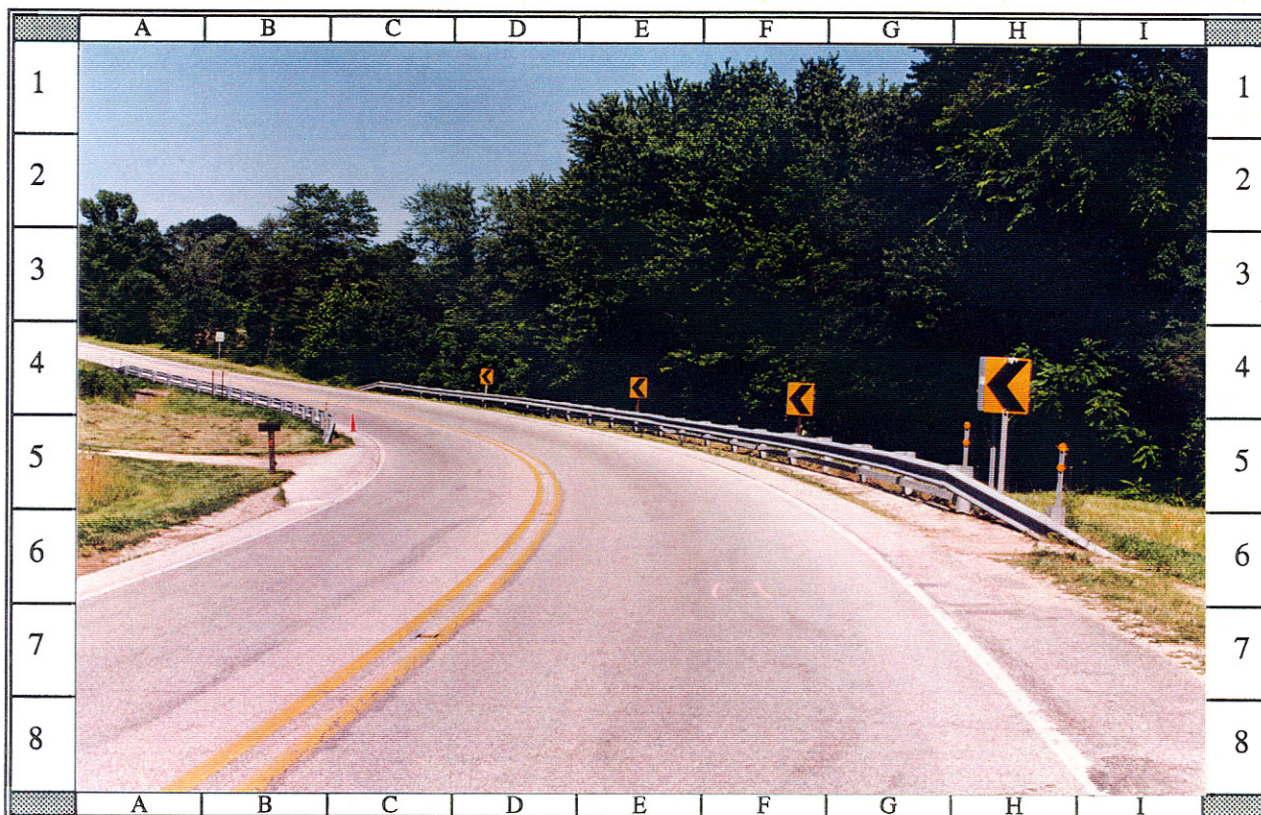
04: Case Vehicle's east-northeastward travel path approximately 20 meters (66 feet) west of impact area; NOTE: double gouges in mid-lane (cell F6)

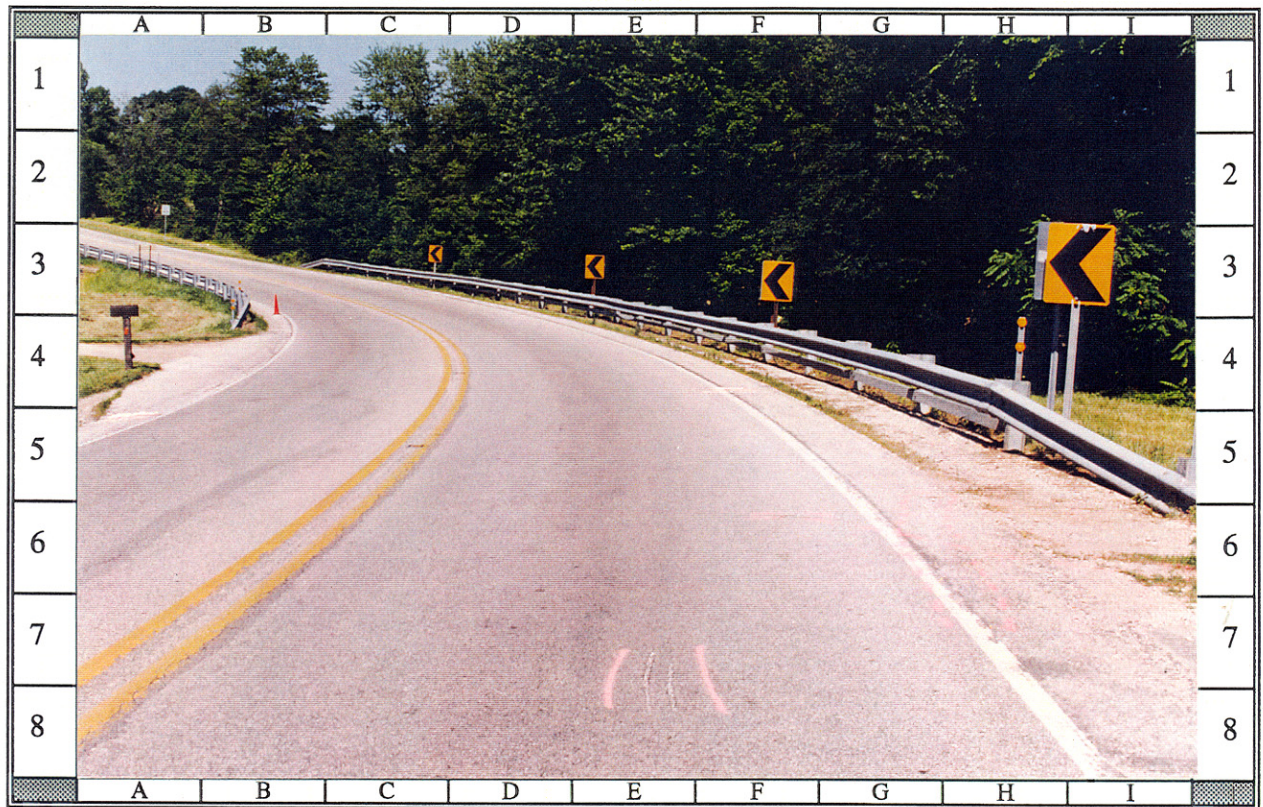
05: Case Vehicle's east-northeastward travel path approximately 10 meters (33 feet) west of impact area; NOTE: two sets of double gouges (cells E7--E8 and F5)

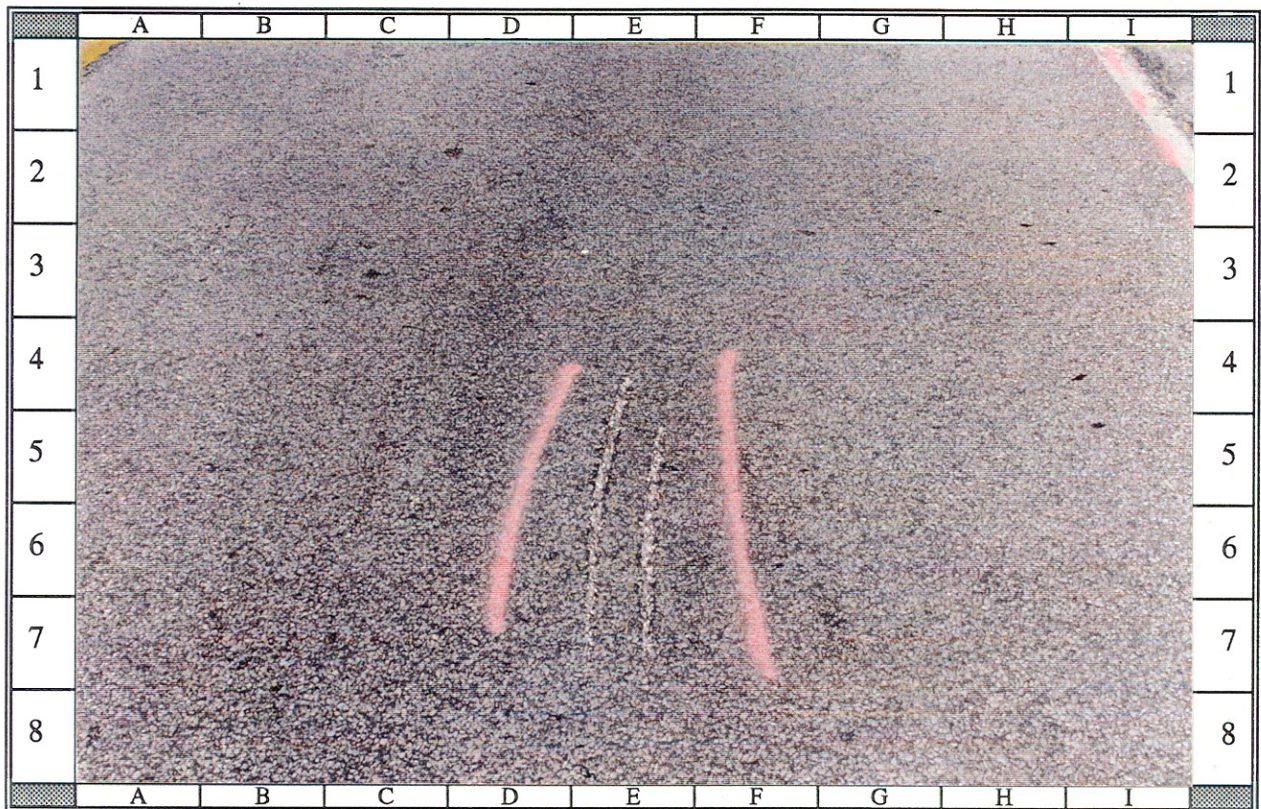
06: Close-up of double gouges in mid-eastbound lane located approximately 5 meters (16 feet) west of impact; NOTE: gouges from Vehicle #2's post-impact travel

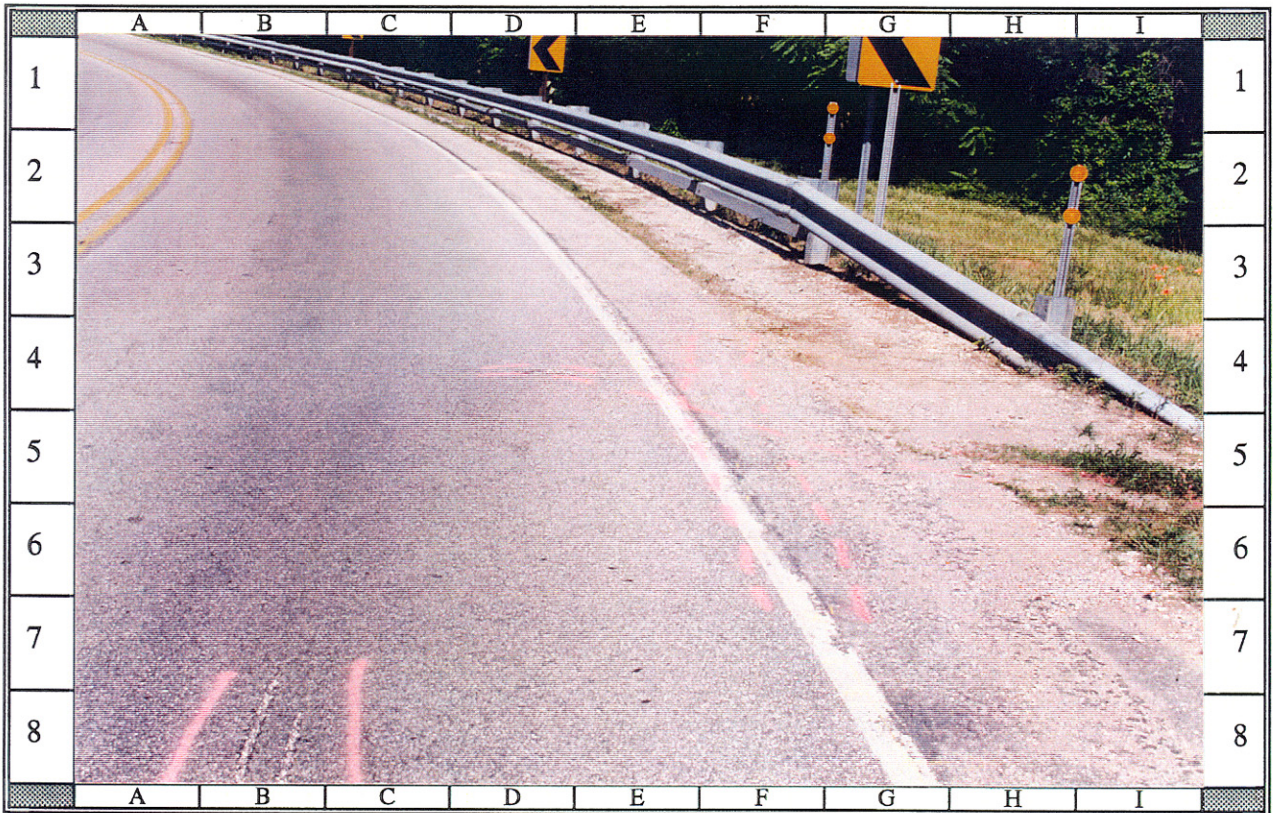
07: Case Vehicle's eastward travel path approximately 5 meters (16 feet) west of impact showing beginning of right front pre-impact skidmark on south edge line

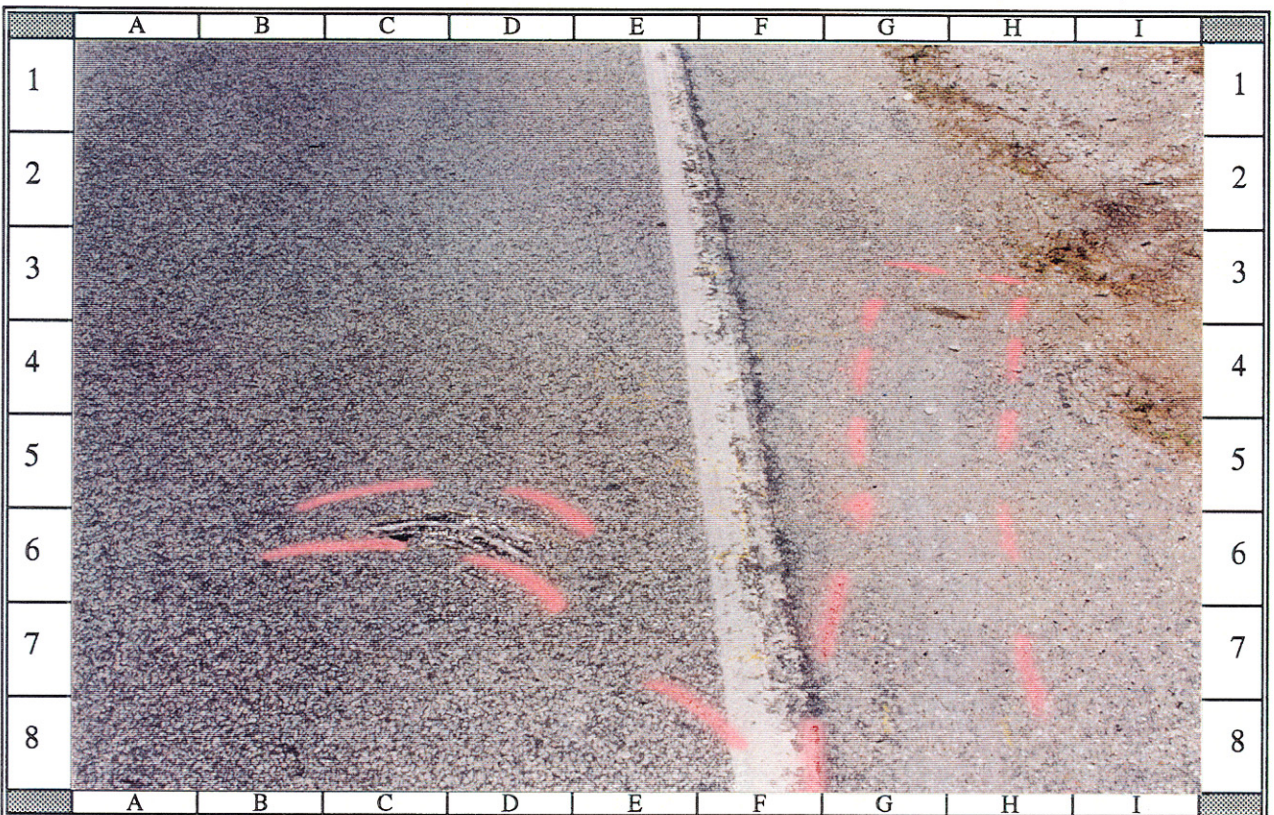
08: Eastward close-up view of Case Vehicle's impact area showing right front skidmark and parallel double gouges from Vehicle #2's post-impact rotation

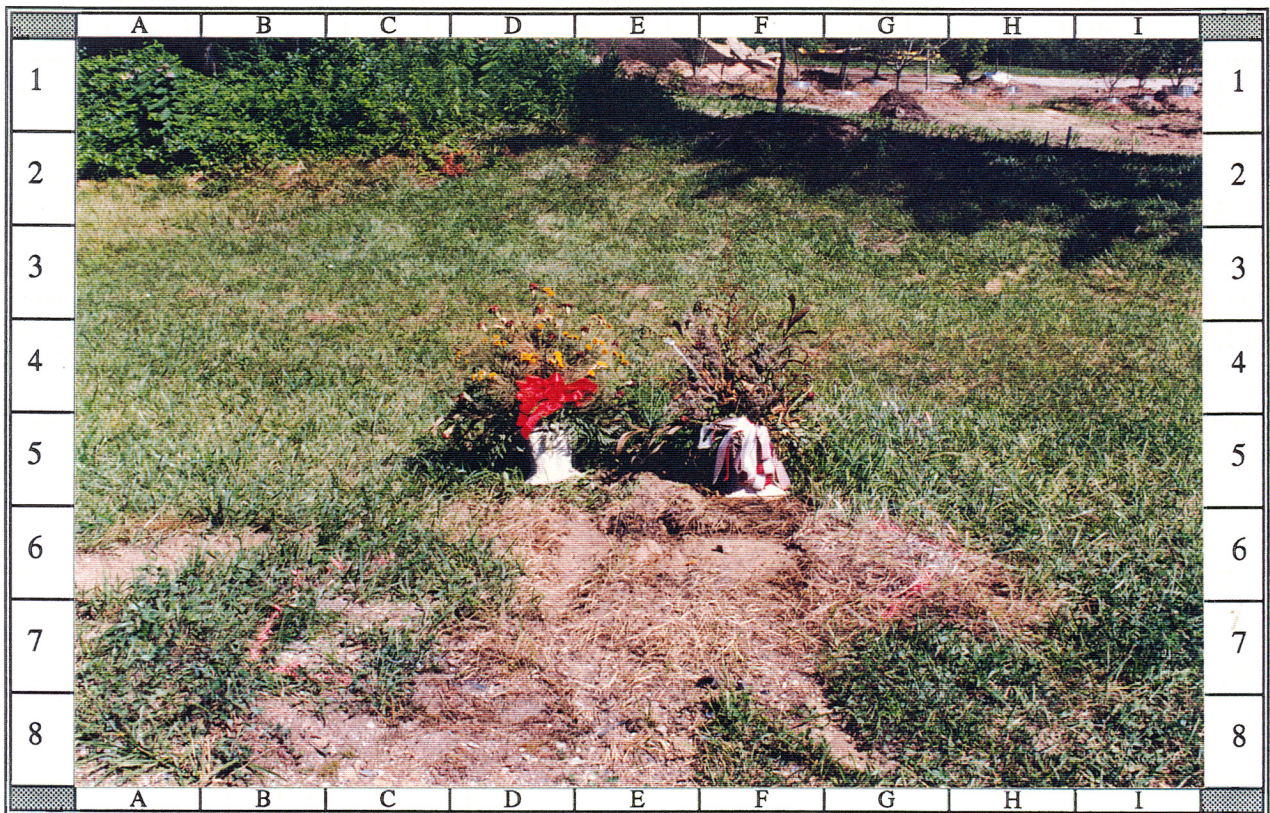
09: South-southeastward view of Case Vehicle's final rest position approximately 7 meters (23 feet) southwest of impact area; NOTE: paint locates tire positions

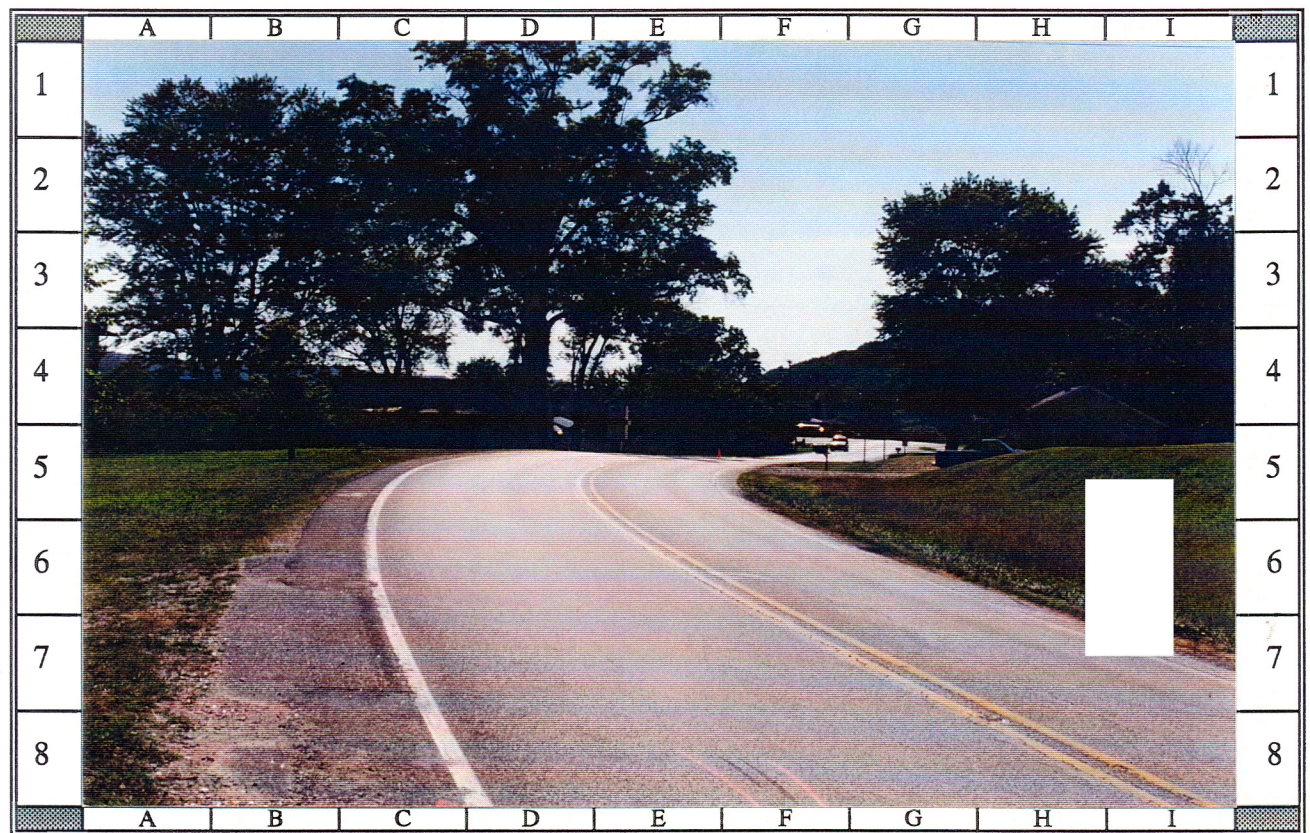
10: North-northwestward view of Case Vehicle's final rest position approximately 7 meters (23 feet) southwest of impact area; NOTE: paint locates tire positions

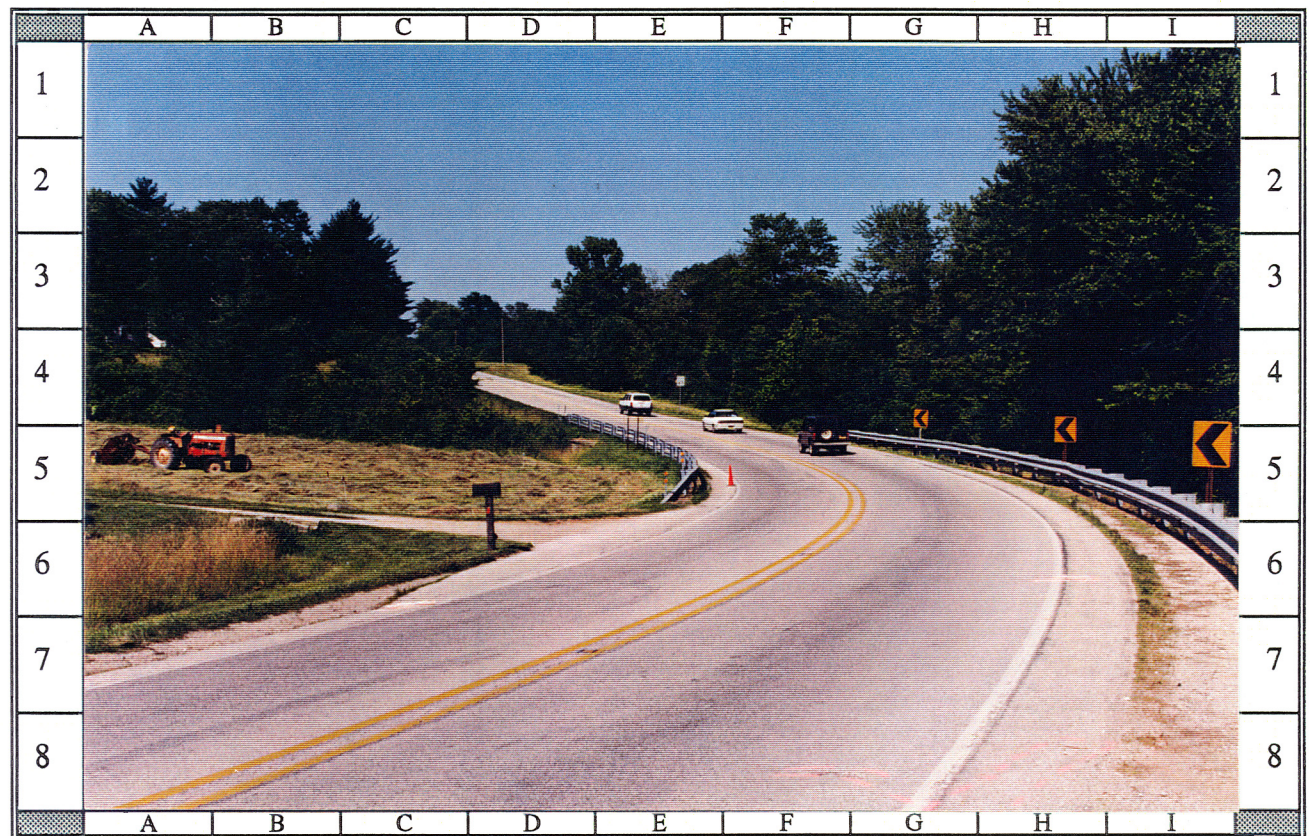
11: Westward view from impact area of Case Vehicle's eastward travel path into left hand curve; NOTE: negative slope in Case Vehicle's direction of travel

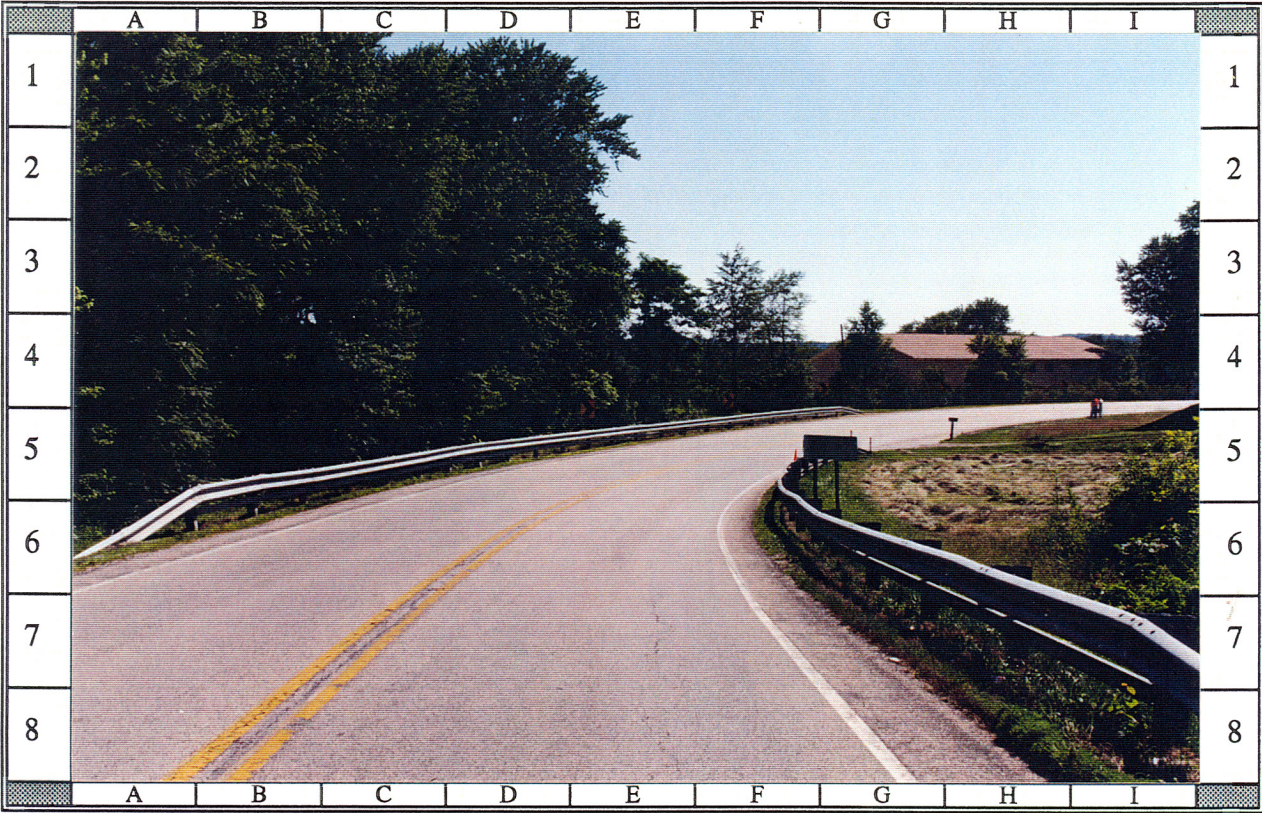
13: Vehicle #2’s southwestward travel path ~ 105 meters (344 feet) northeast of impact; NOTE: decreasing radius right hand curve and negative grade

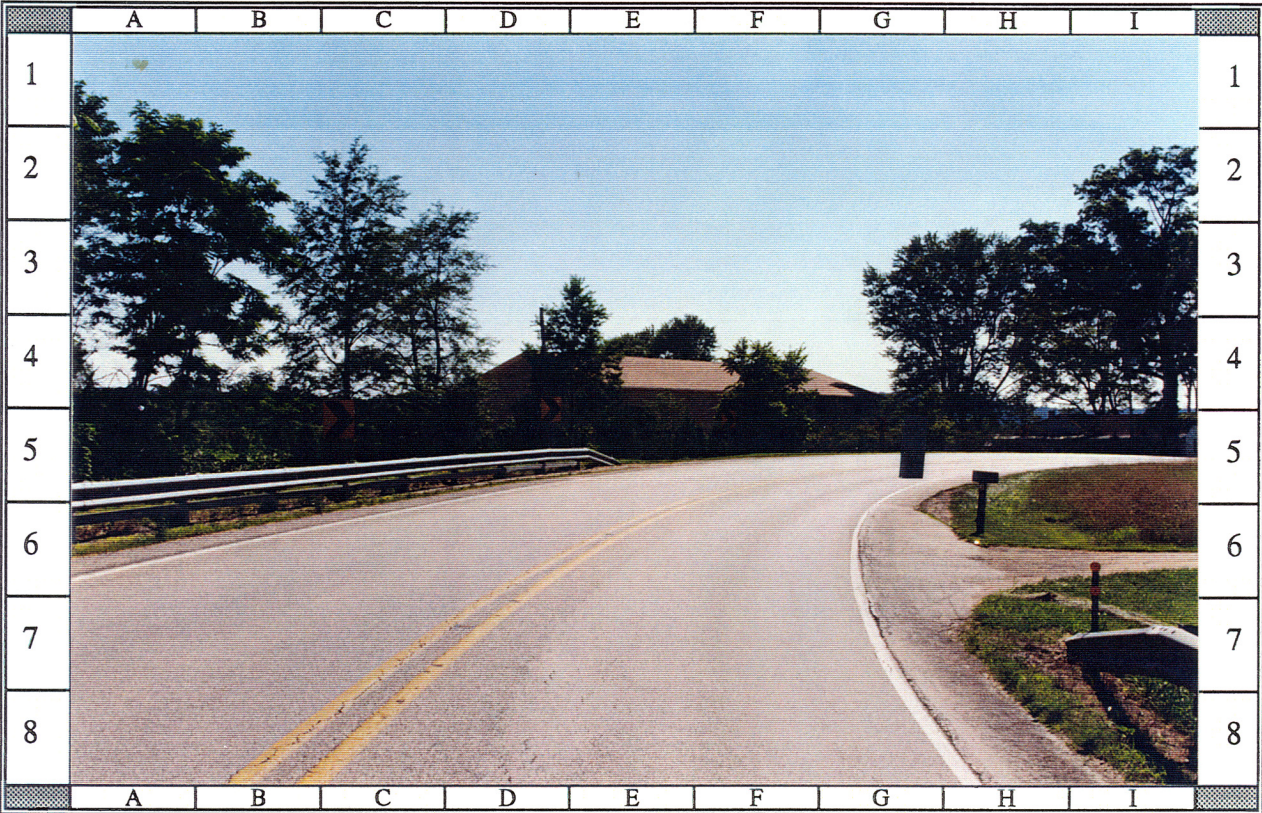
14: Vehicle #2’s southwestward travel path approximately 50 meters (164 feet) northeast of impact; NOTE: Vehicle #2 has traversed sag and grade is positive

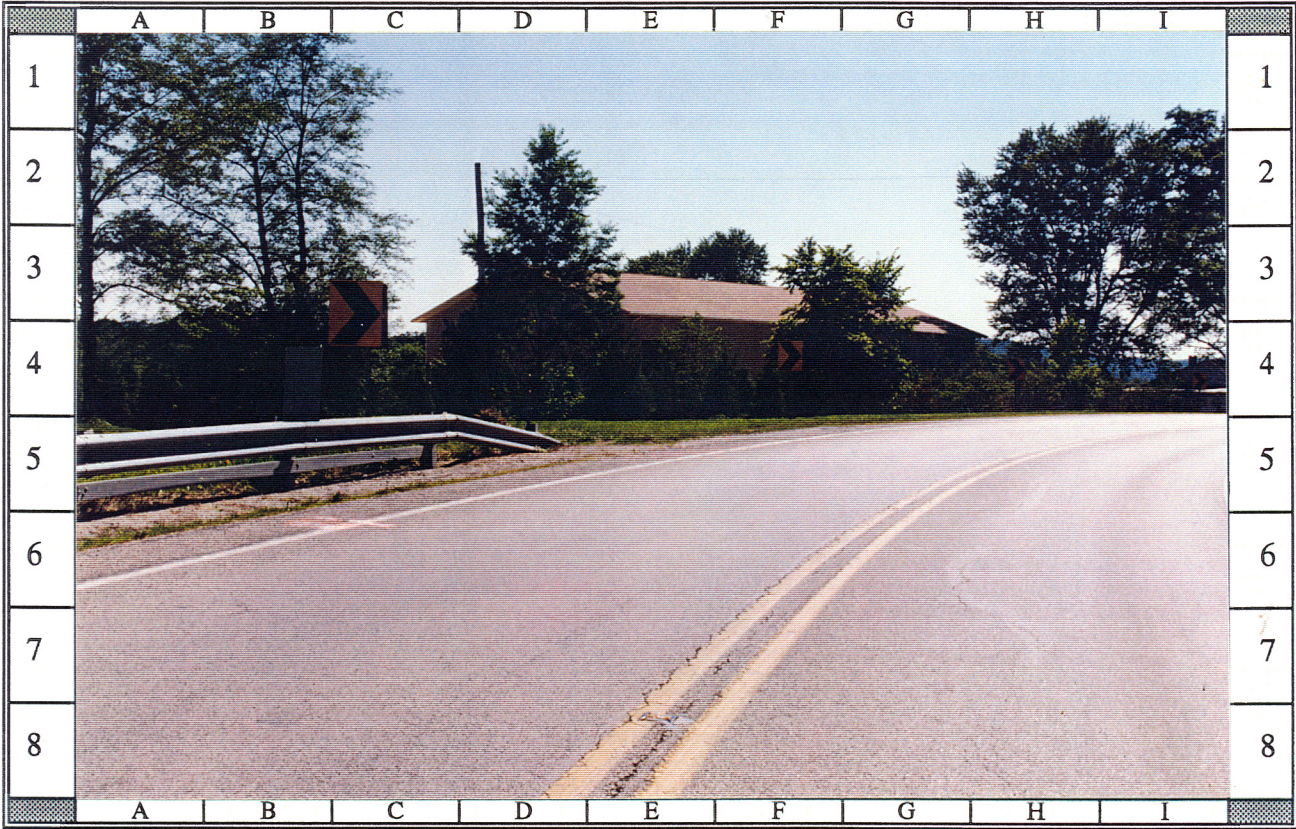
15: Vehicle #2’s southwestward travel path approximately 16 meters (52 feet) north-east of impact; NOTE: impact is midway along south guardrail’s end section

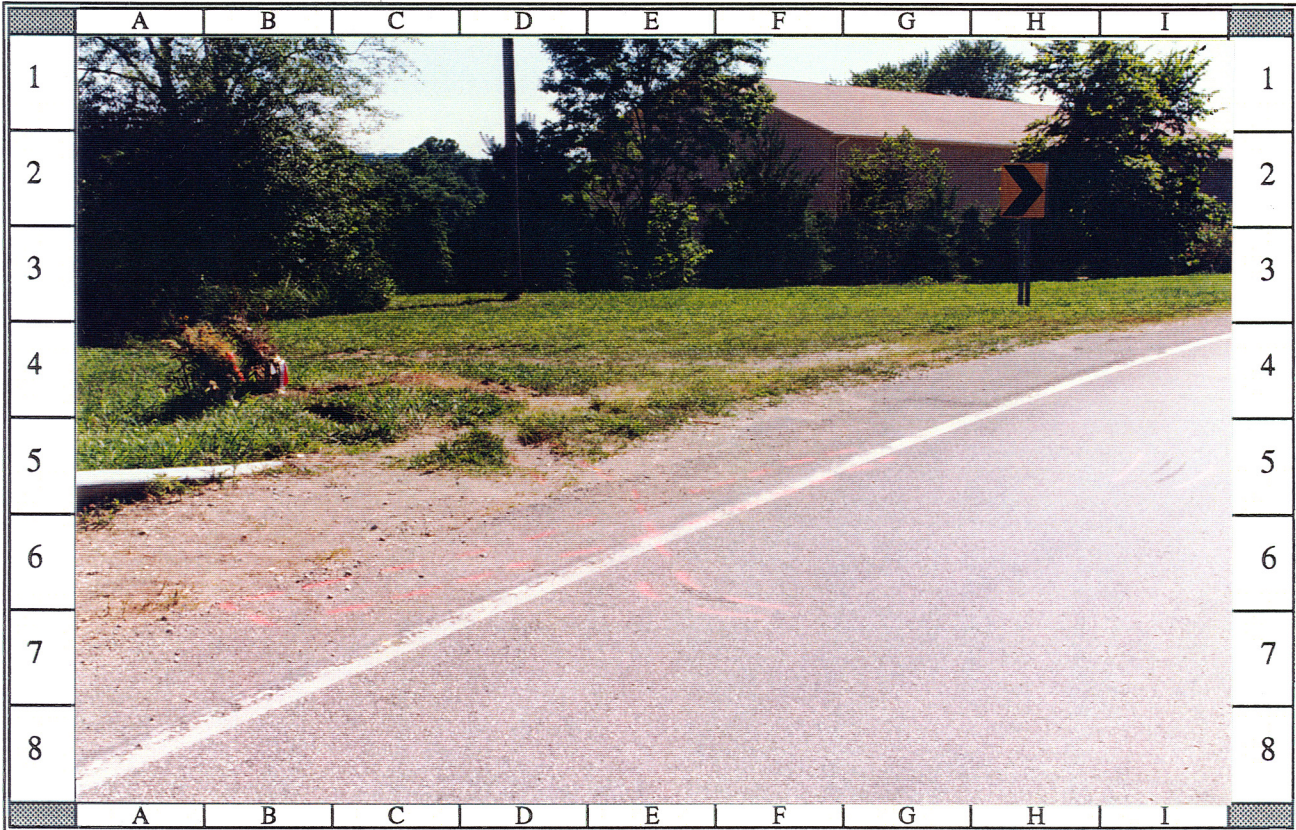
16: Southwestward view of Vehicle #2’s impact area; NOTE: no pre-impact skid-marks by Vehicle #2 and final rest location of Case Vehicle in background

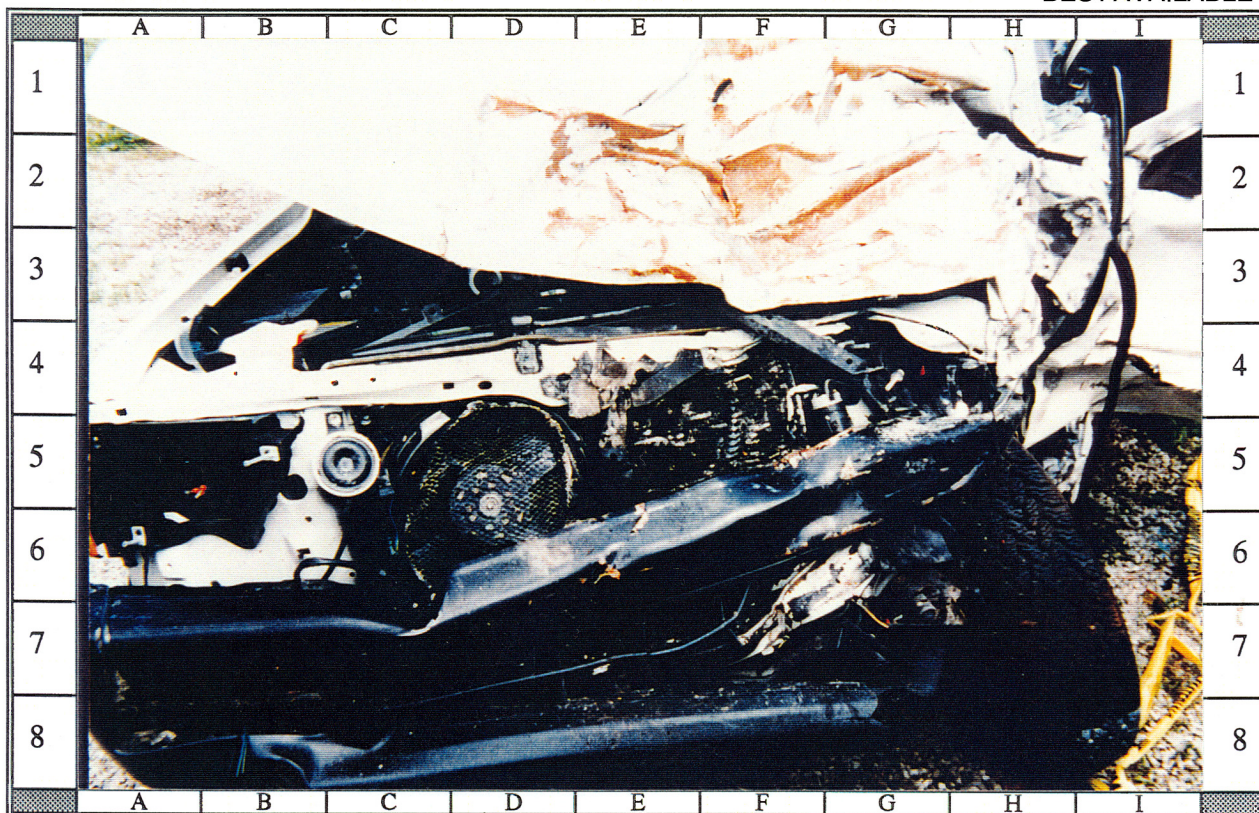
22: Case Vehicle's frontal damage viewed from front; NOTE: severe crush to front left half and leftward end shift

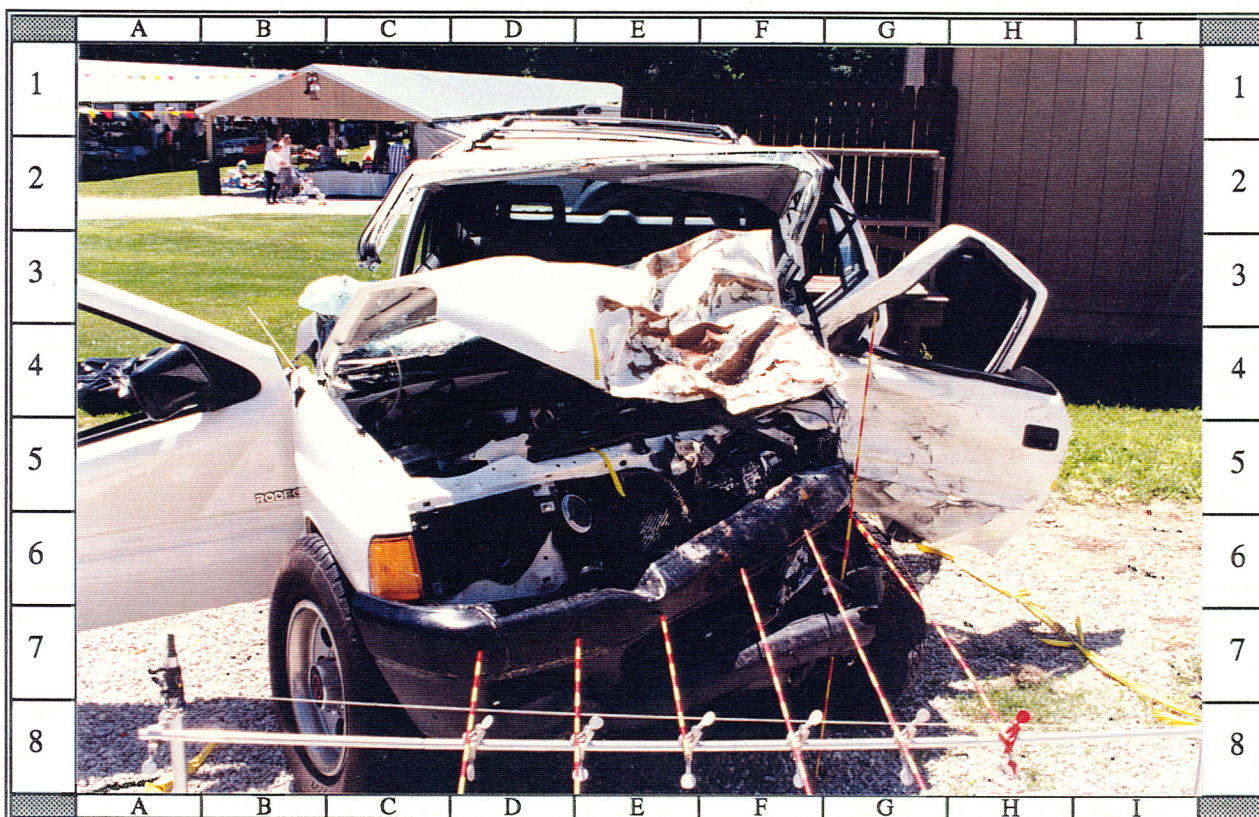
23: Close-up of Case Vehicle's front left damage viewed from approximately 30 degrees left of front

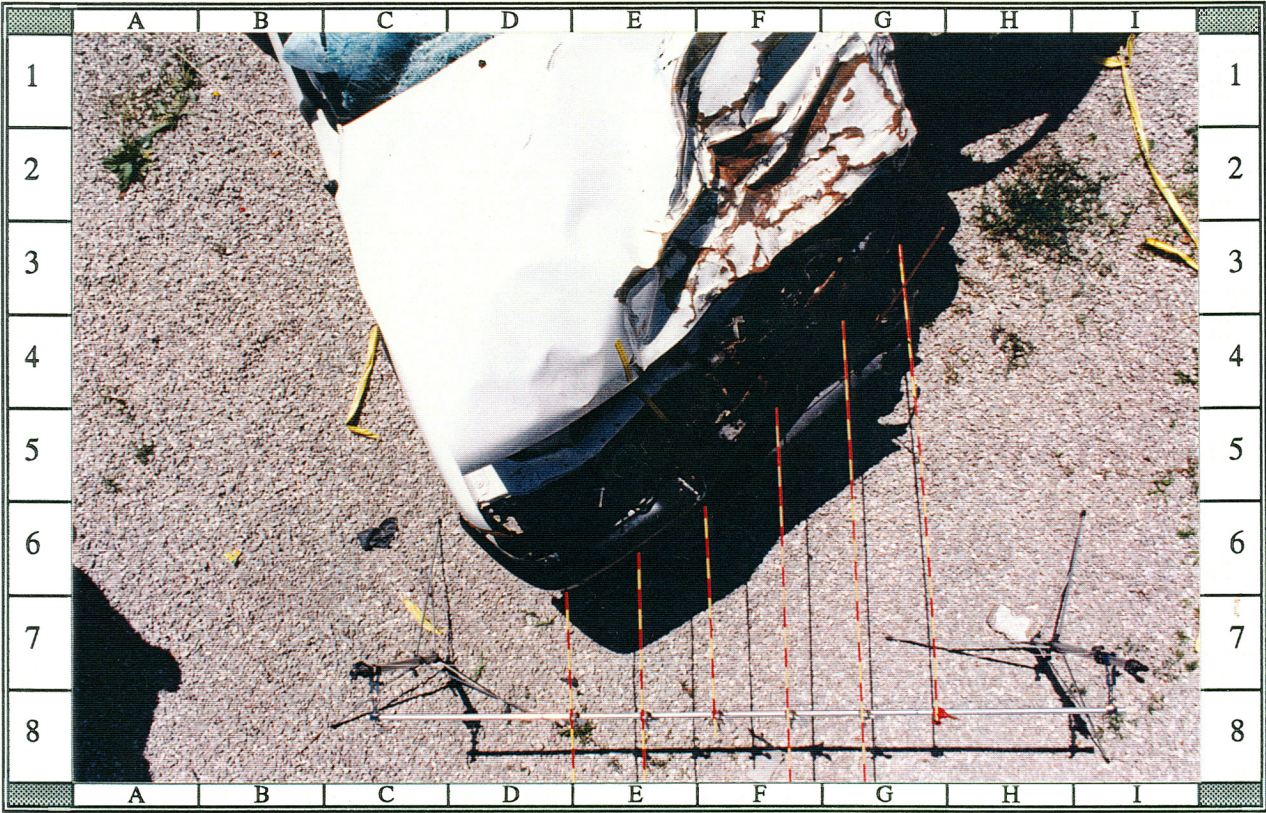
24: Case Vehicle's damaged front with contour gauge present; NOTE: direct damage extends from yellow tape (cells E4--E5) to the left front corner

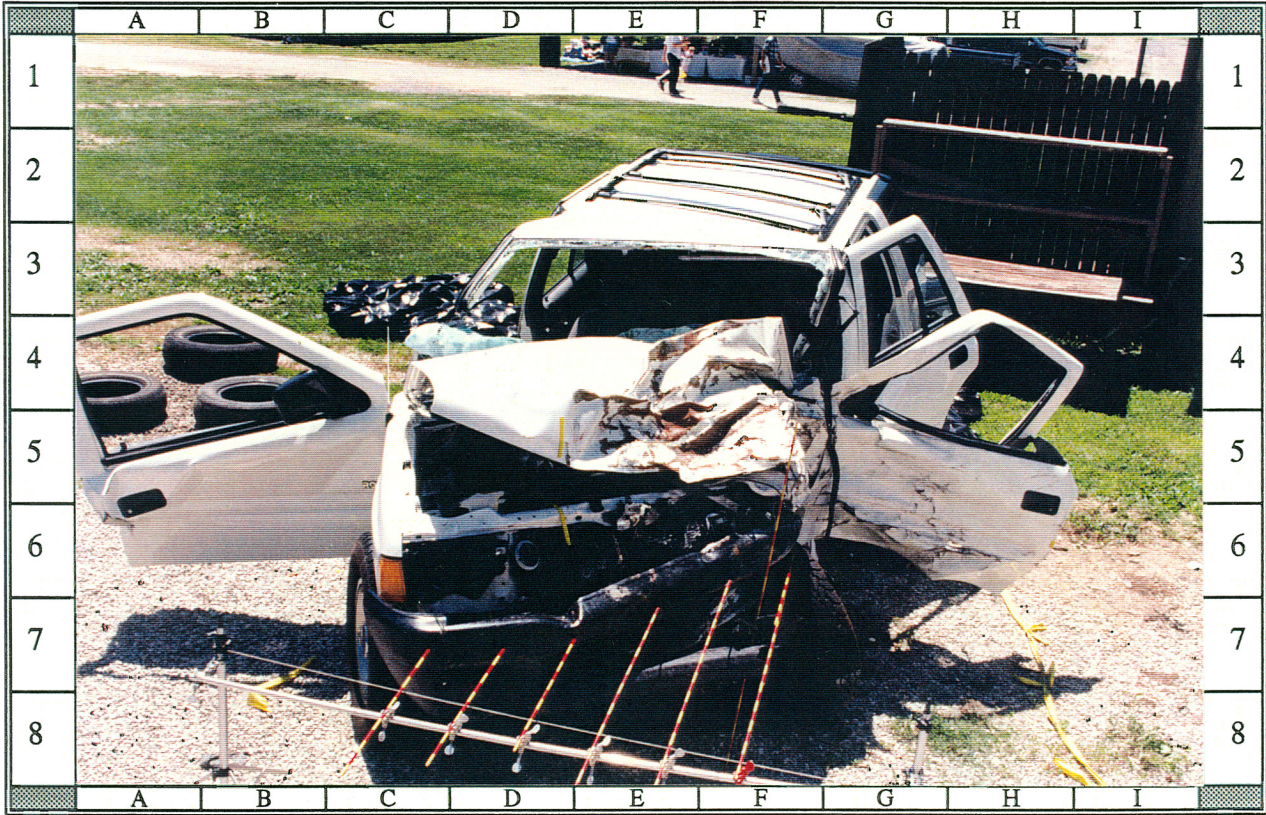
25: Overhead view of Case Vehicle's front left damage with contour gauge present showing extensive crush to front-left corner and leftward end shift

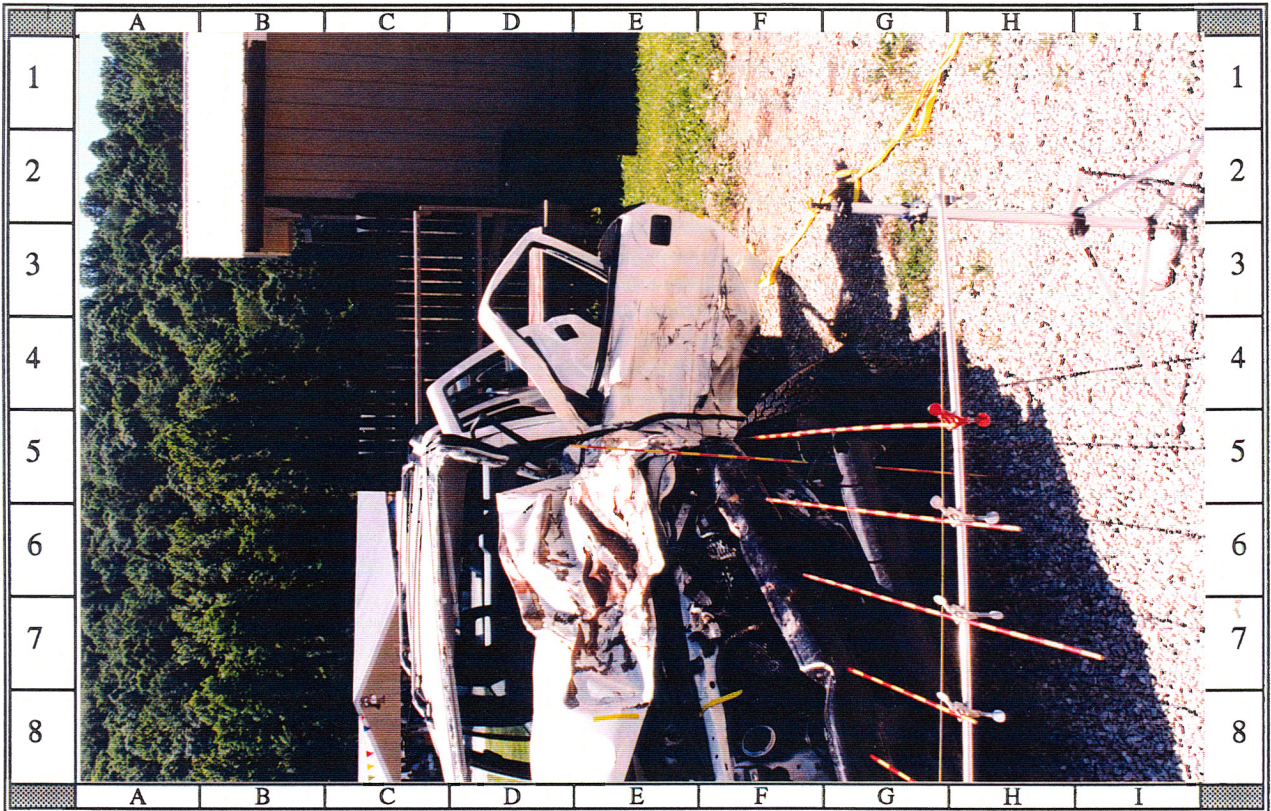
26: Front overhead view of Case Vehicle's front left damage viewed from ~ 30 degrees left of front; NOTE: direct damage extends to mid-left driver's door

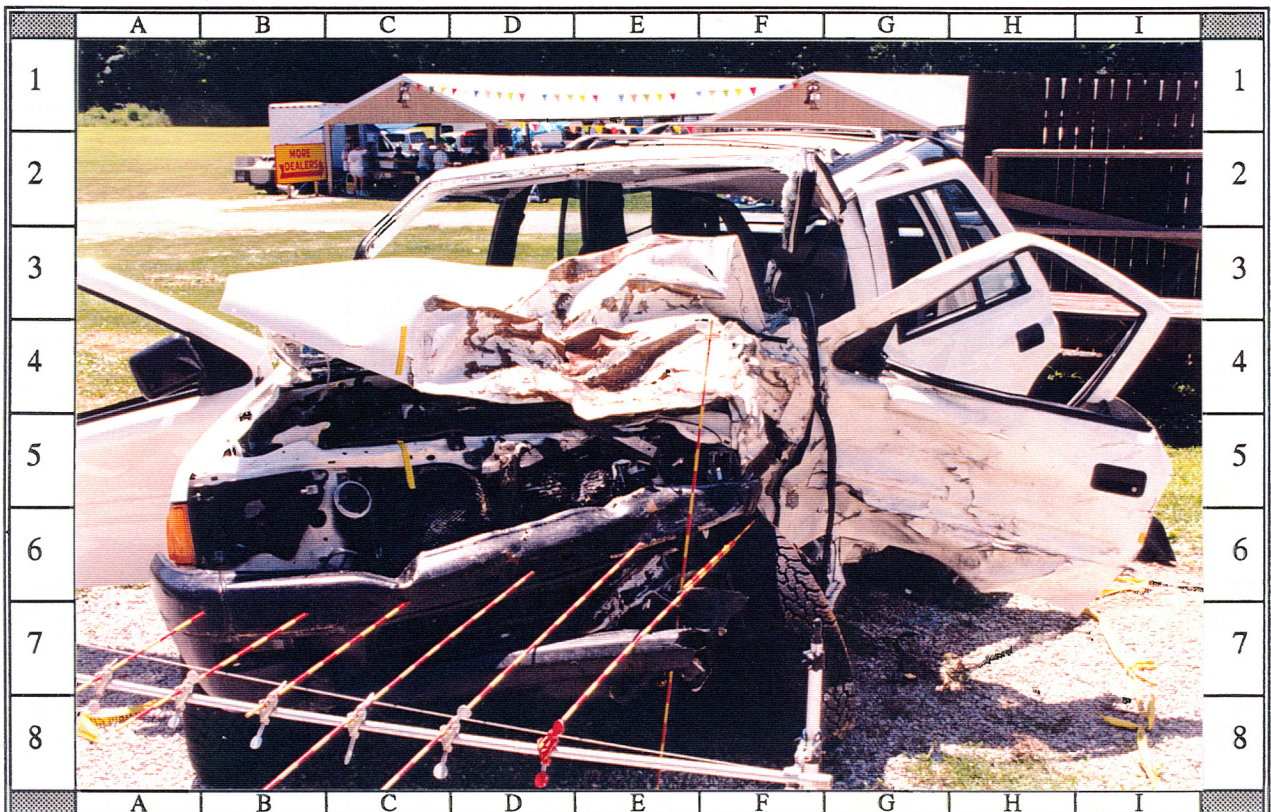
27: Reference line view of Case Vehicle's damaged front and left side viewed from front showing severe front left crush and left front door damage and tire position
